**Town of Summerville
Tree Protection Board Meeting
June 8, 2020 – 9:00 am
Town Hall, Town Council Chambers**

STAFF REPORT
Tree Protection Committee Meeting
June 1, 2020

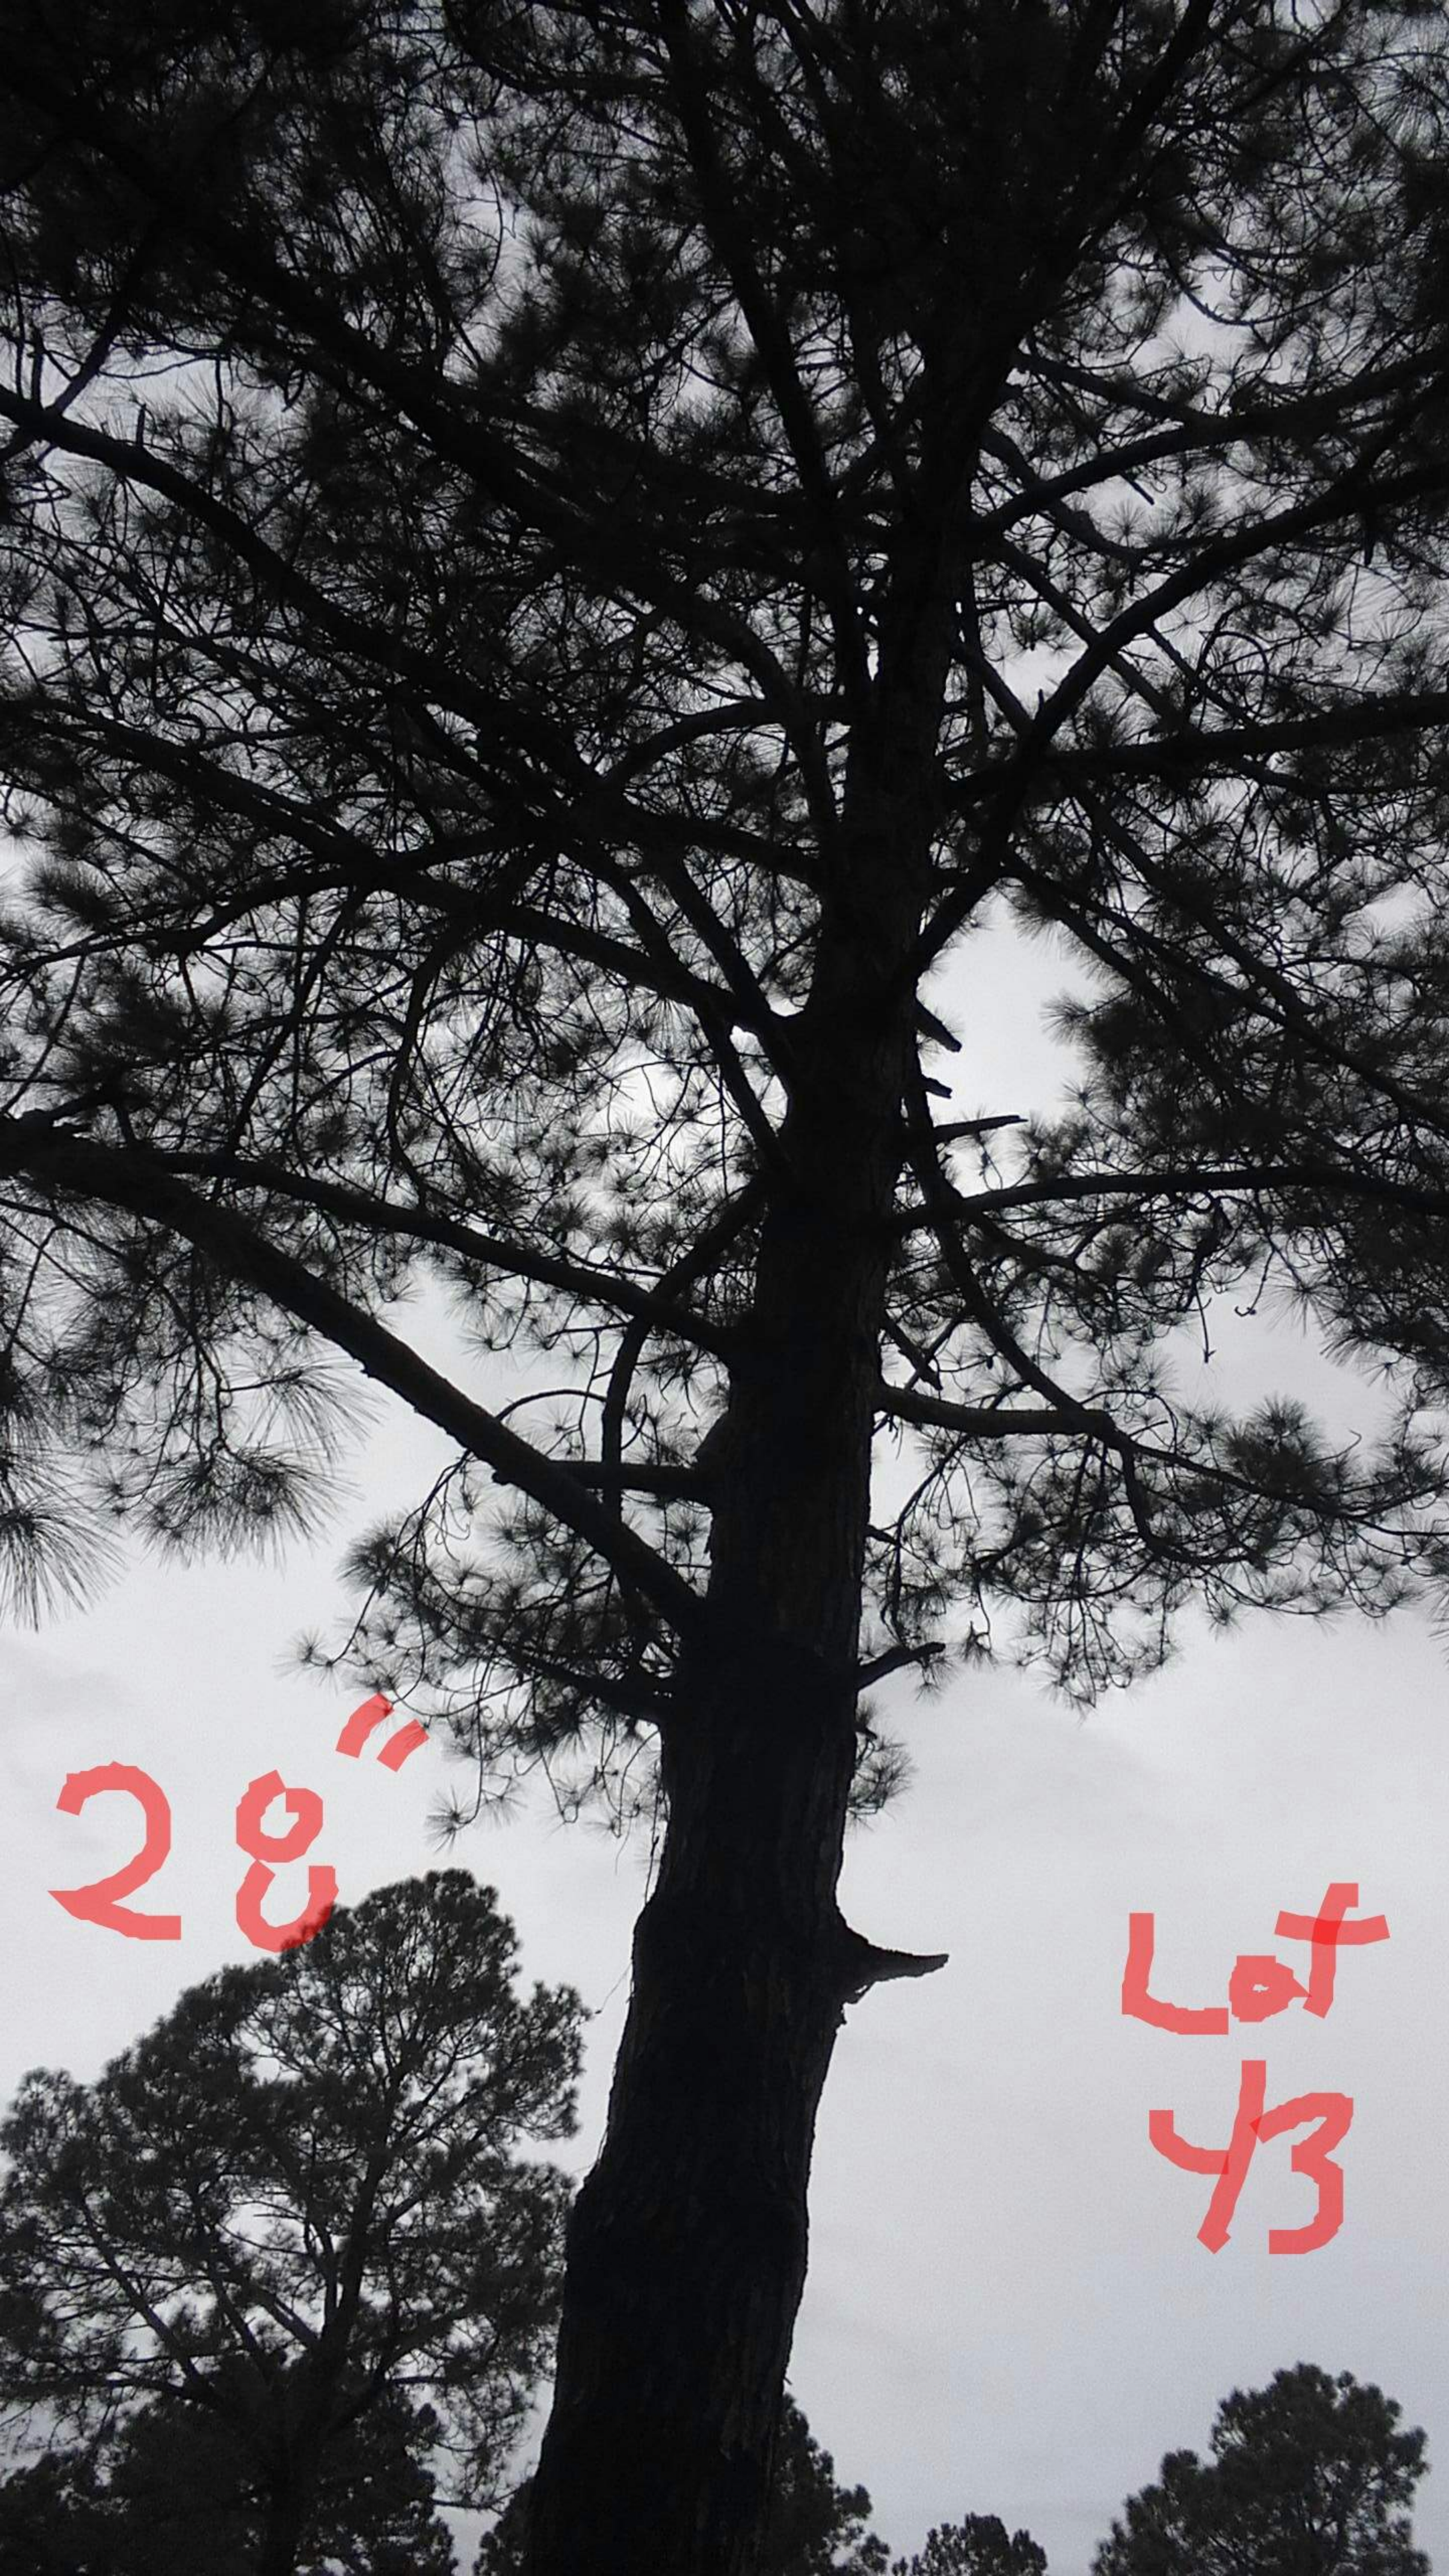
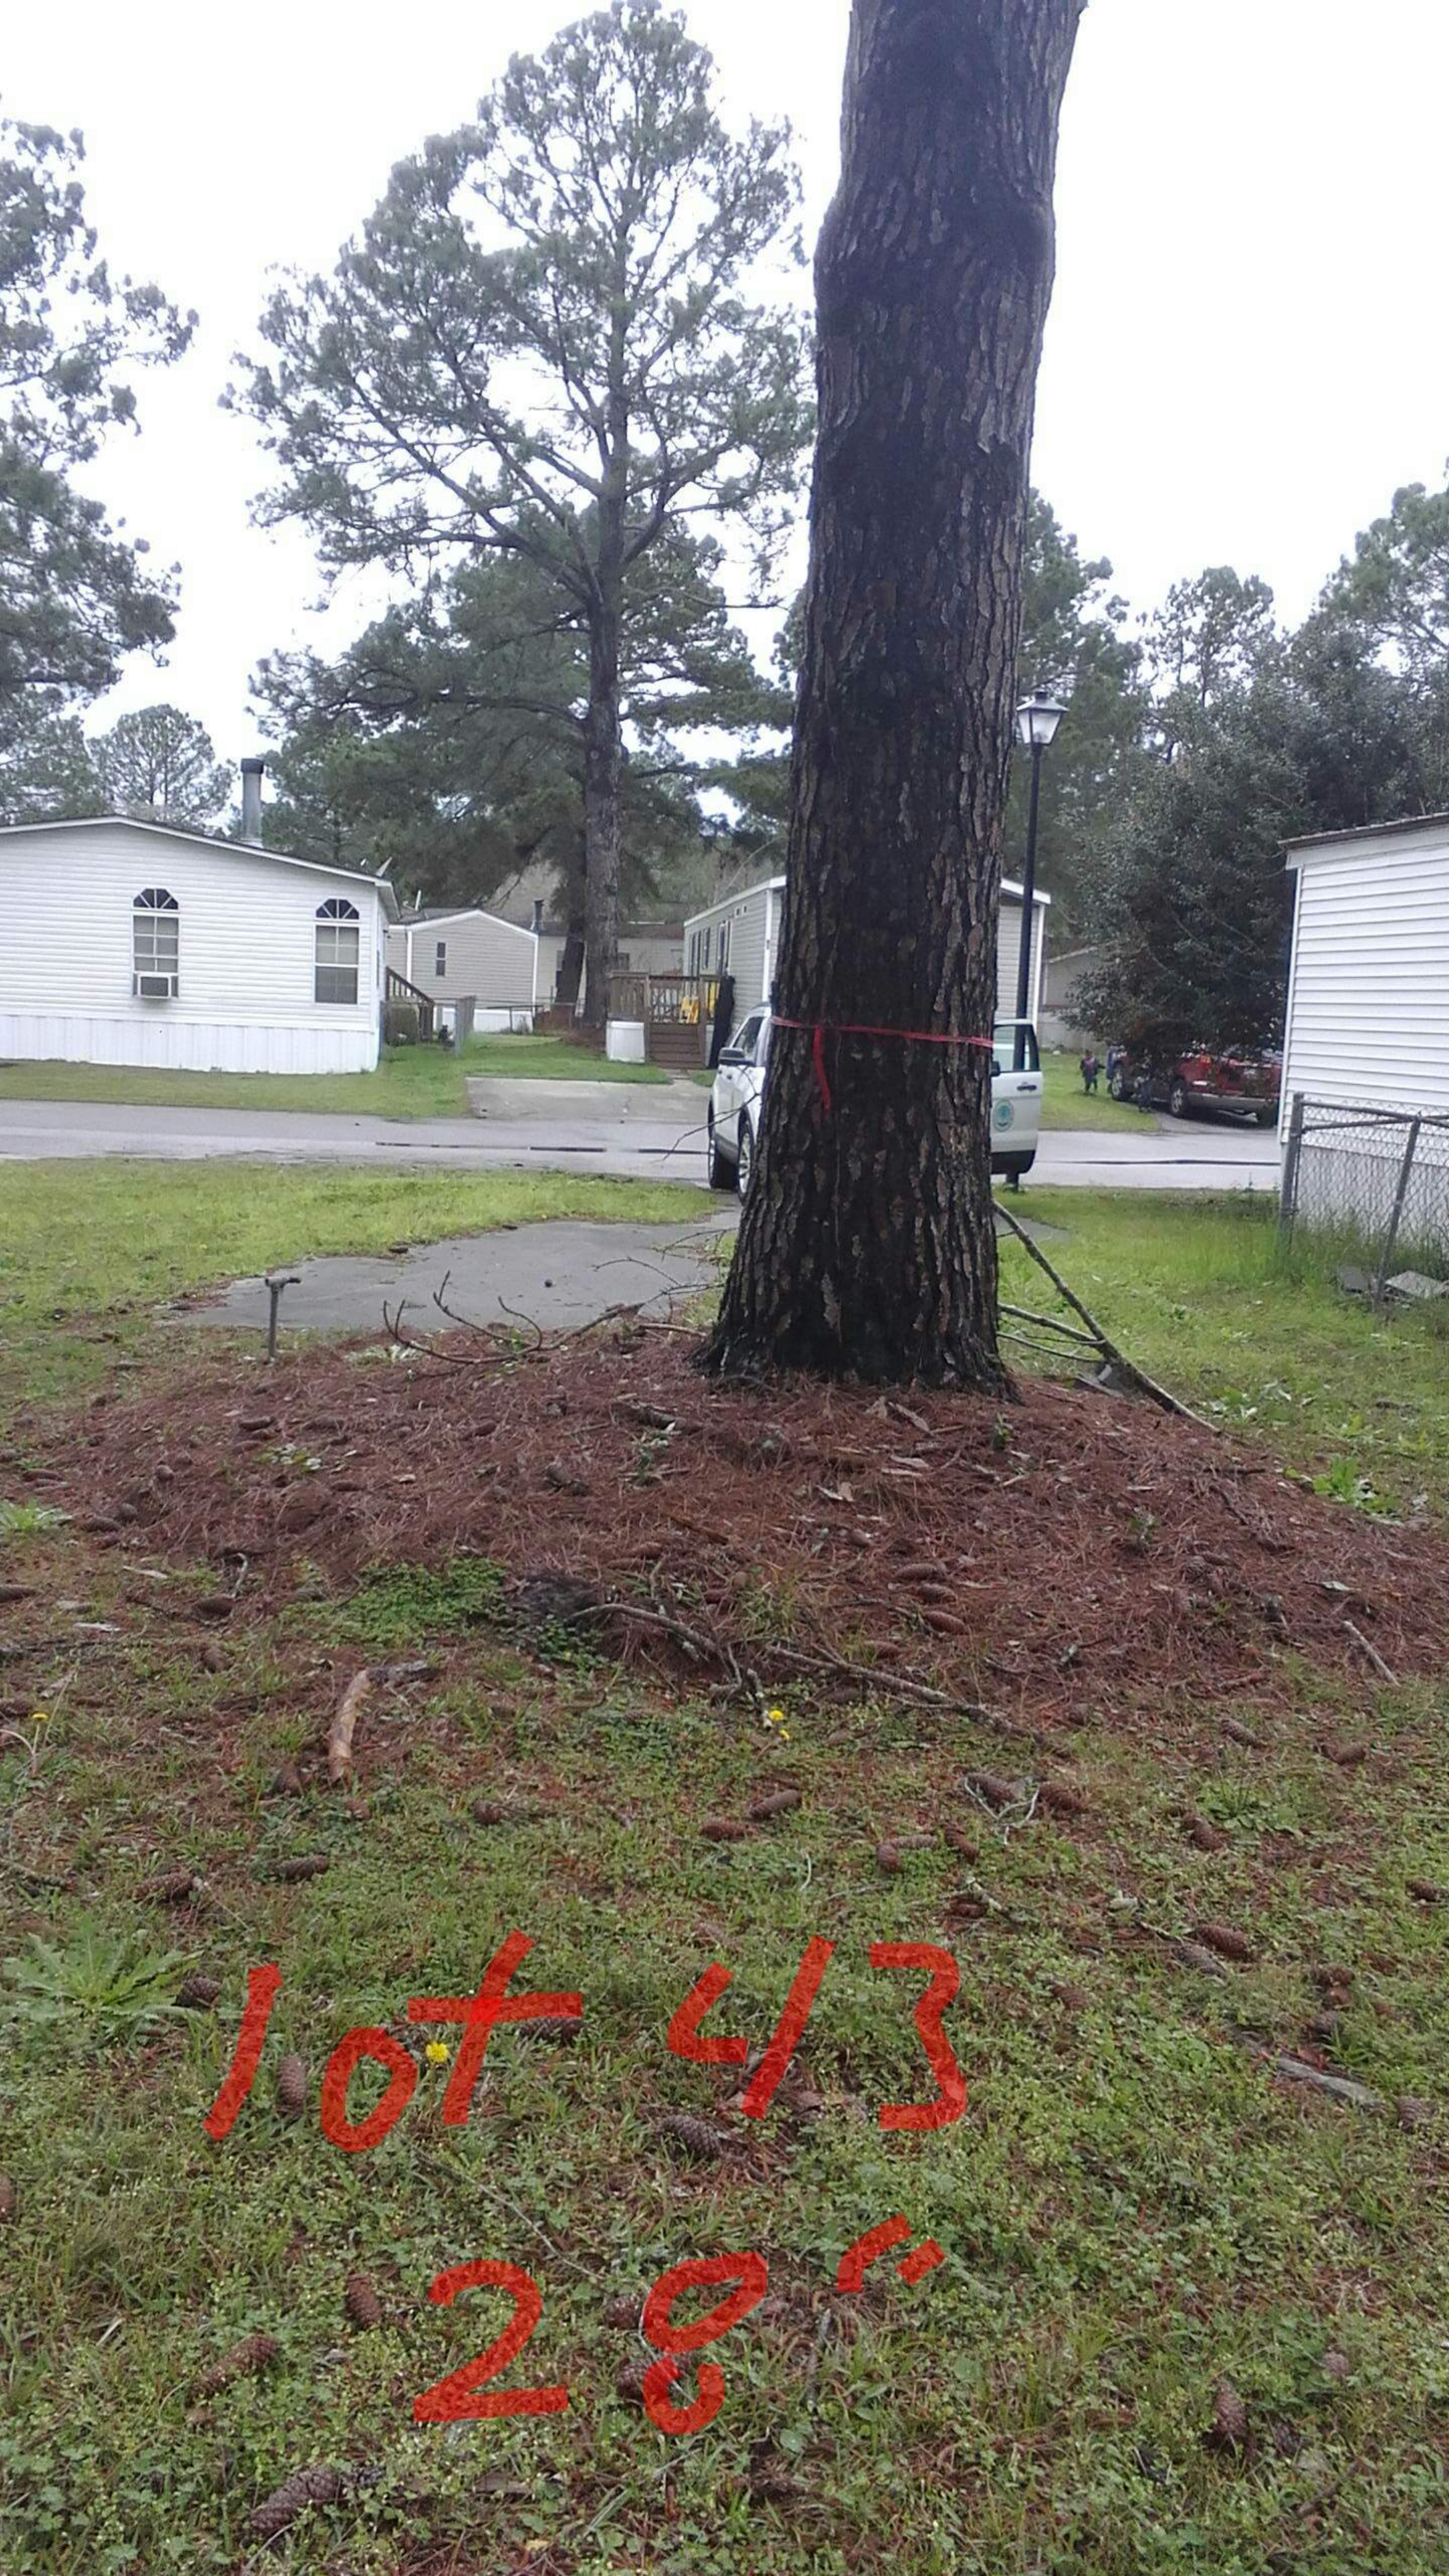
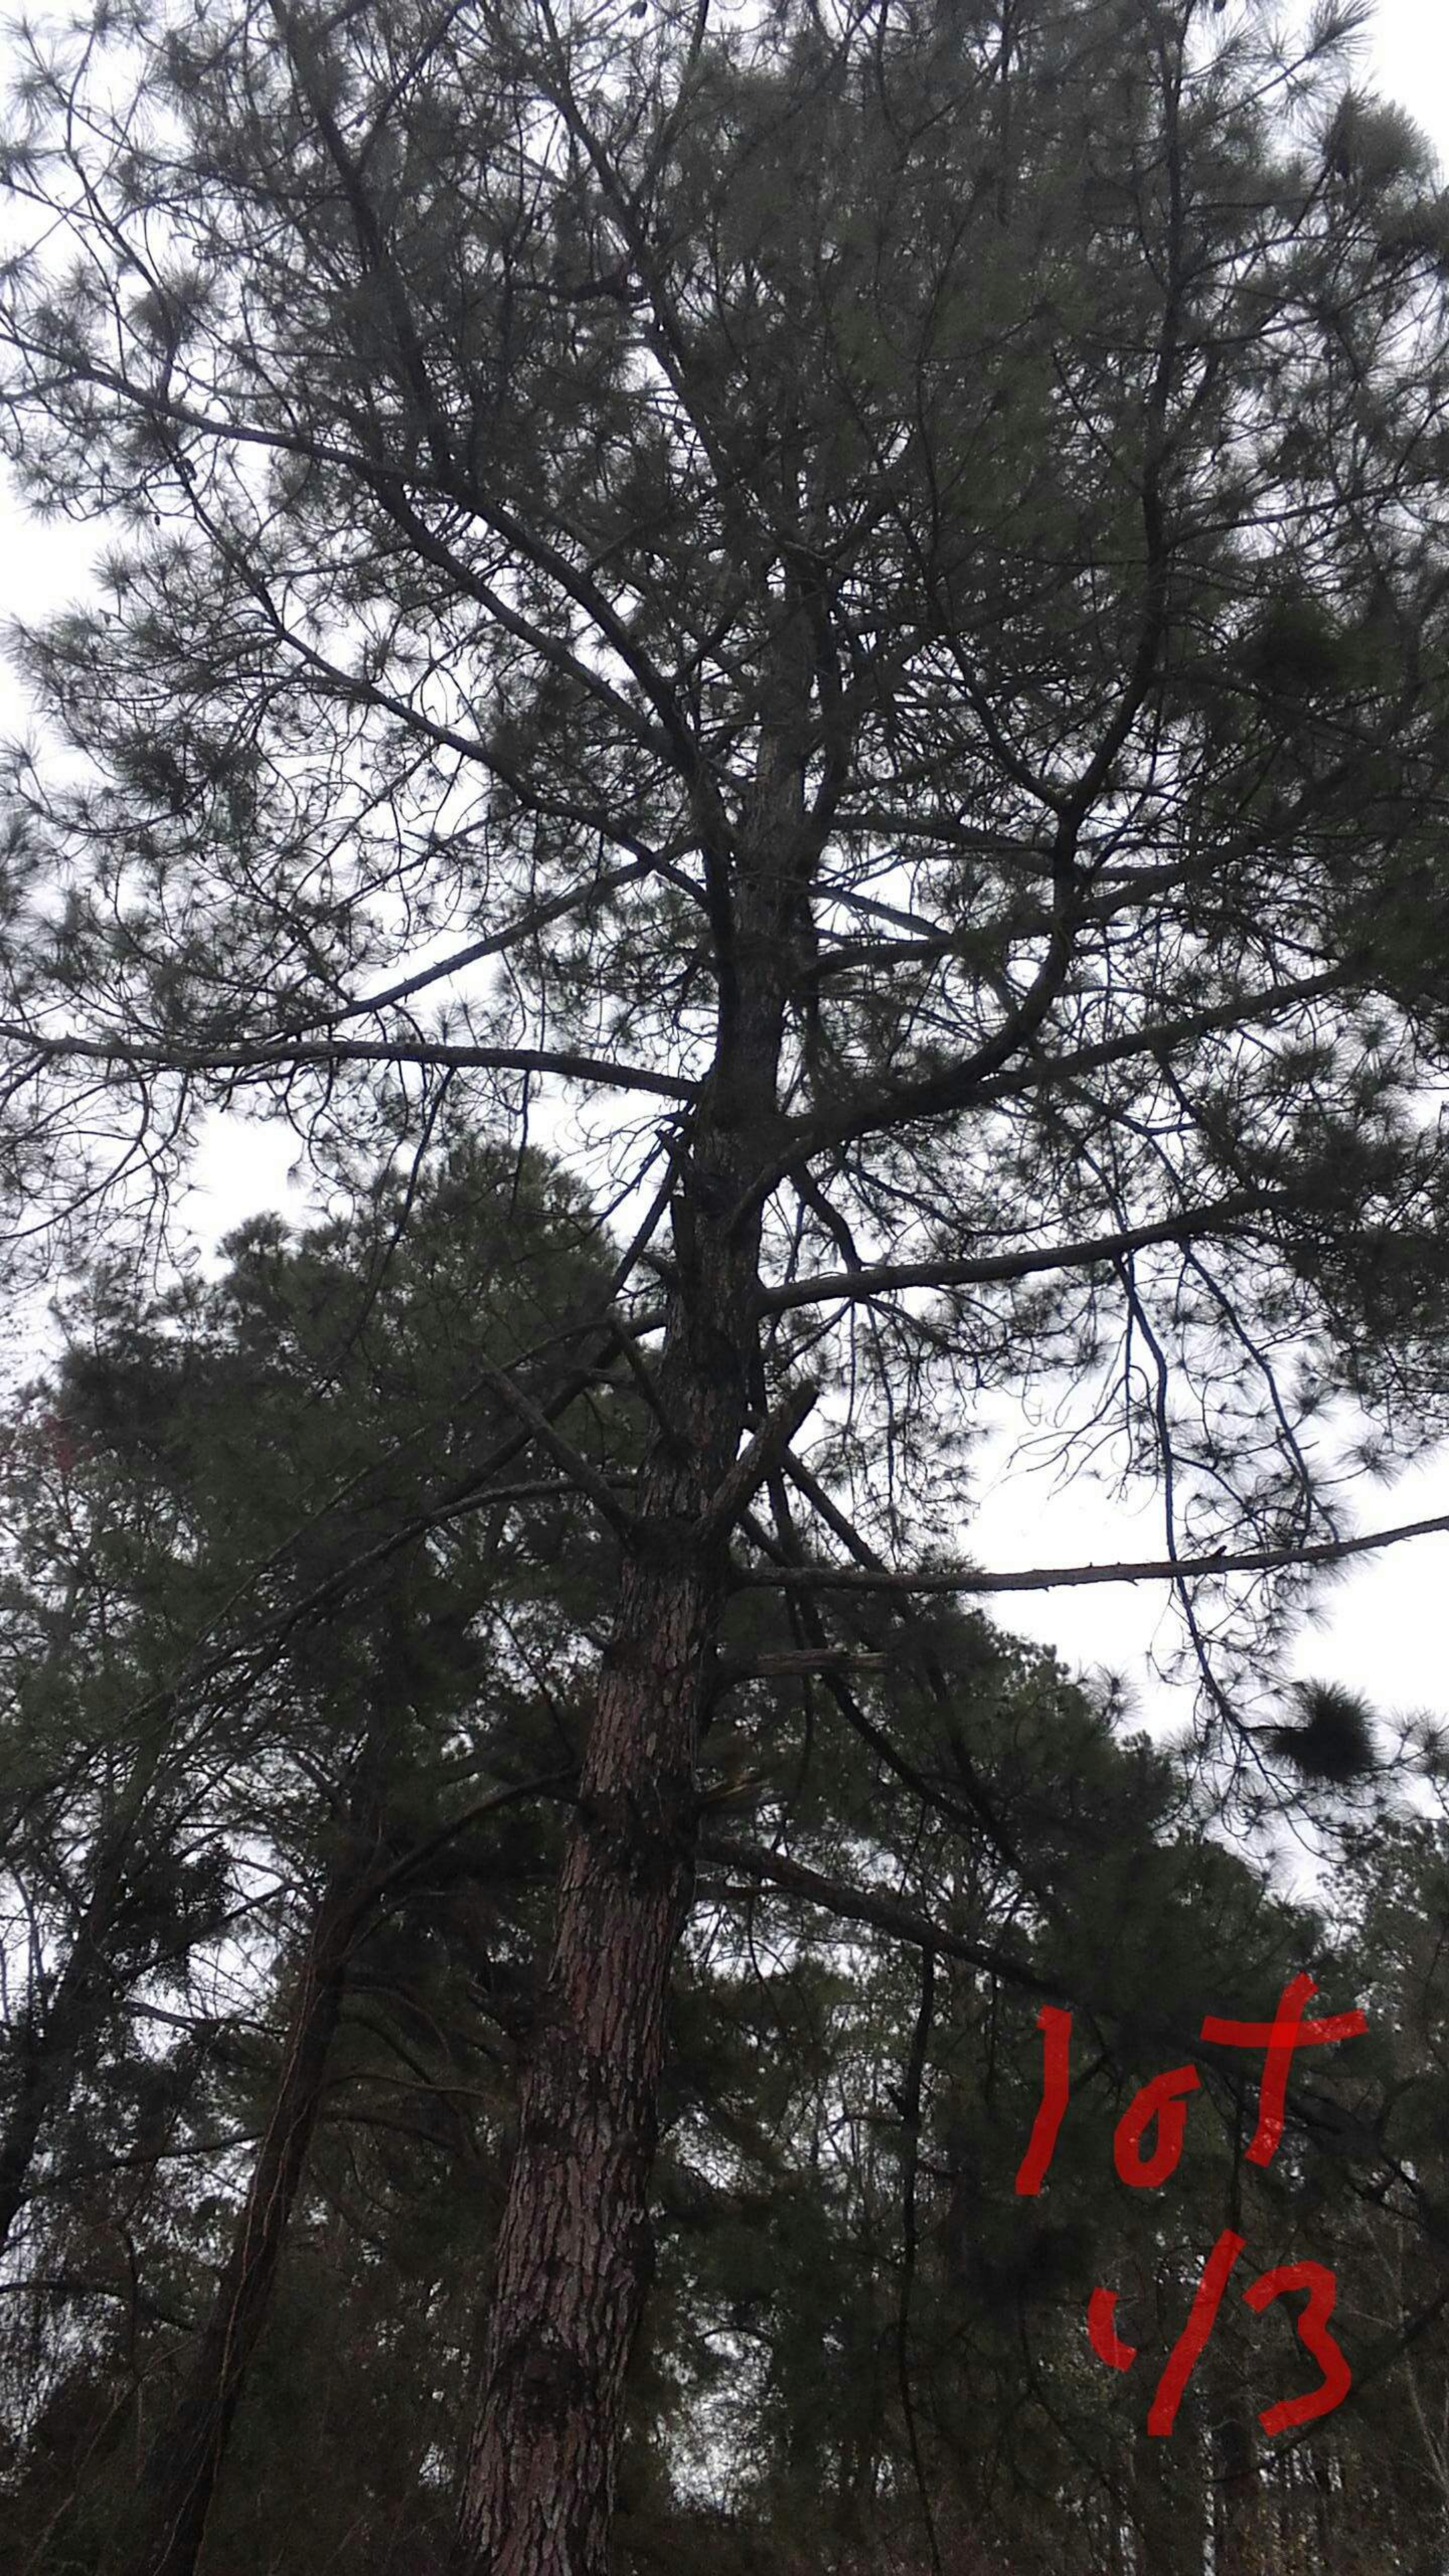
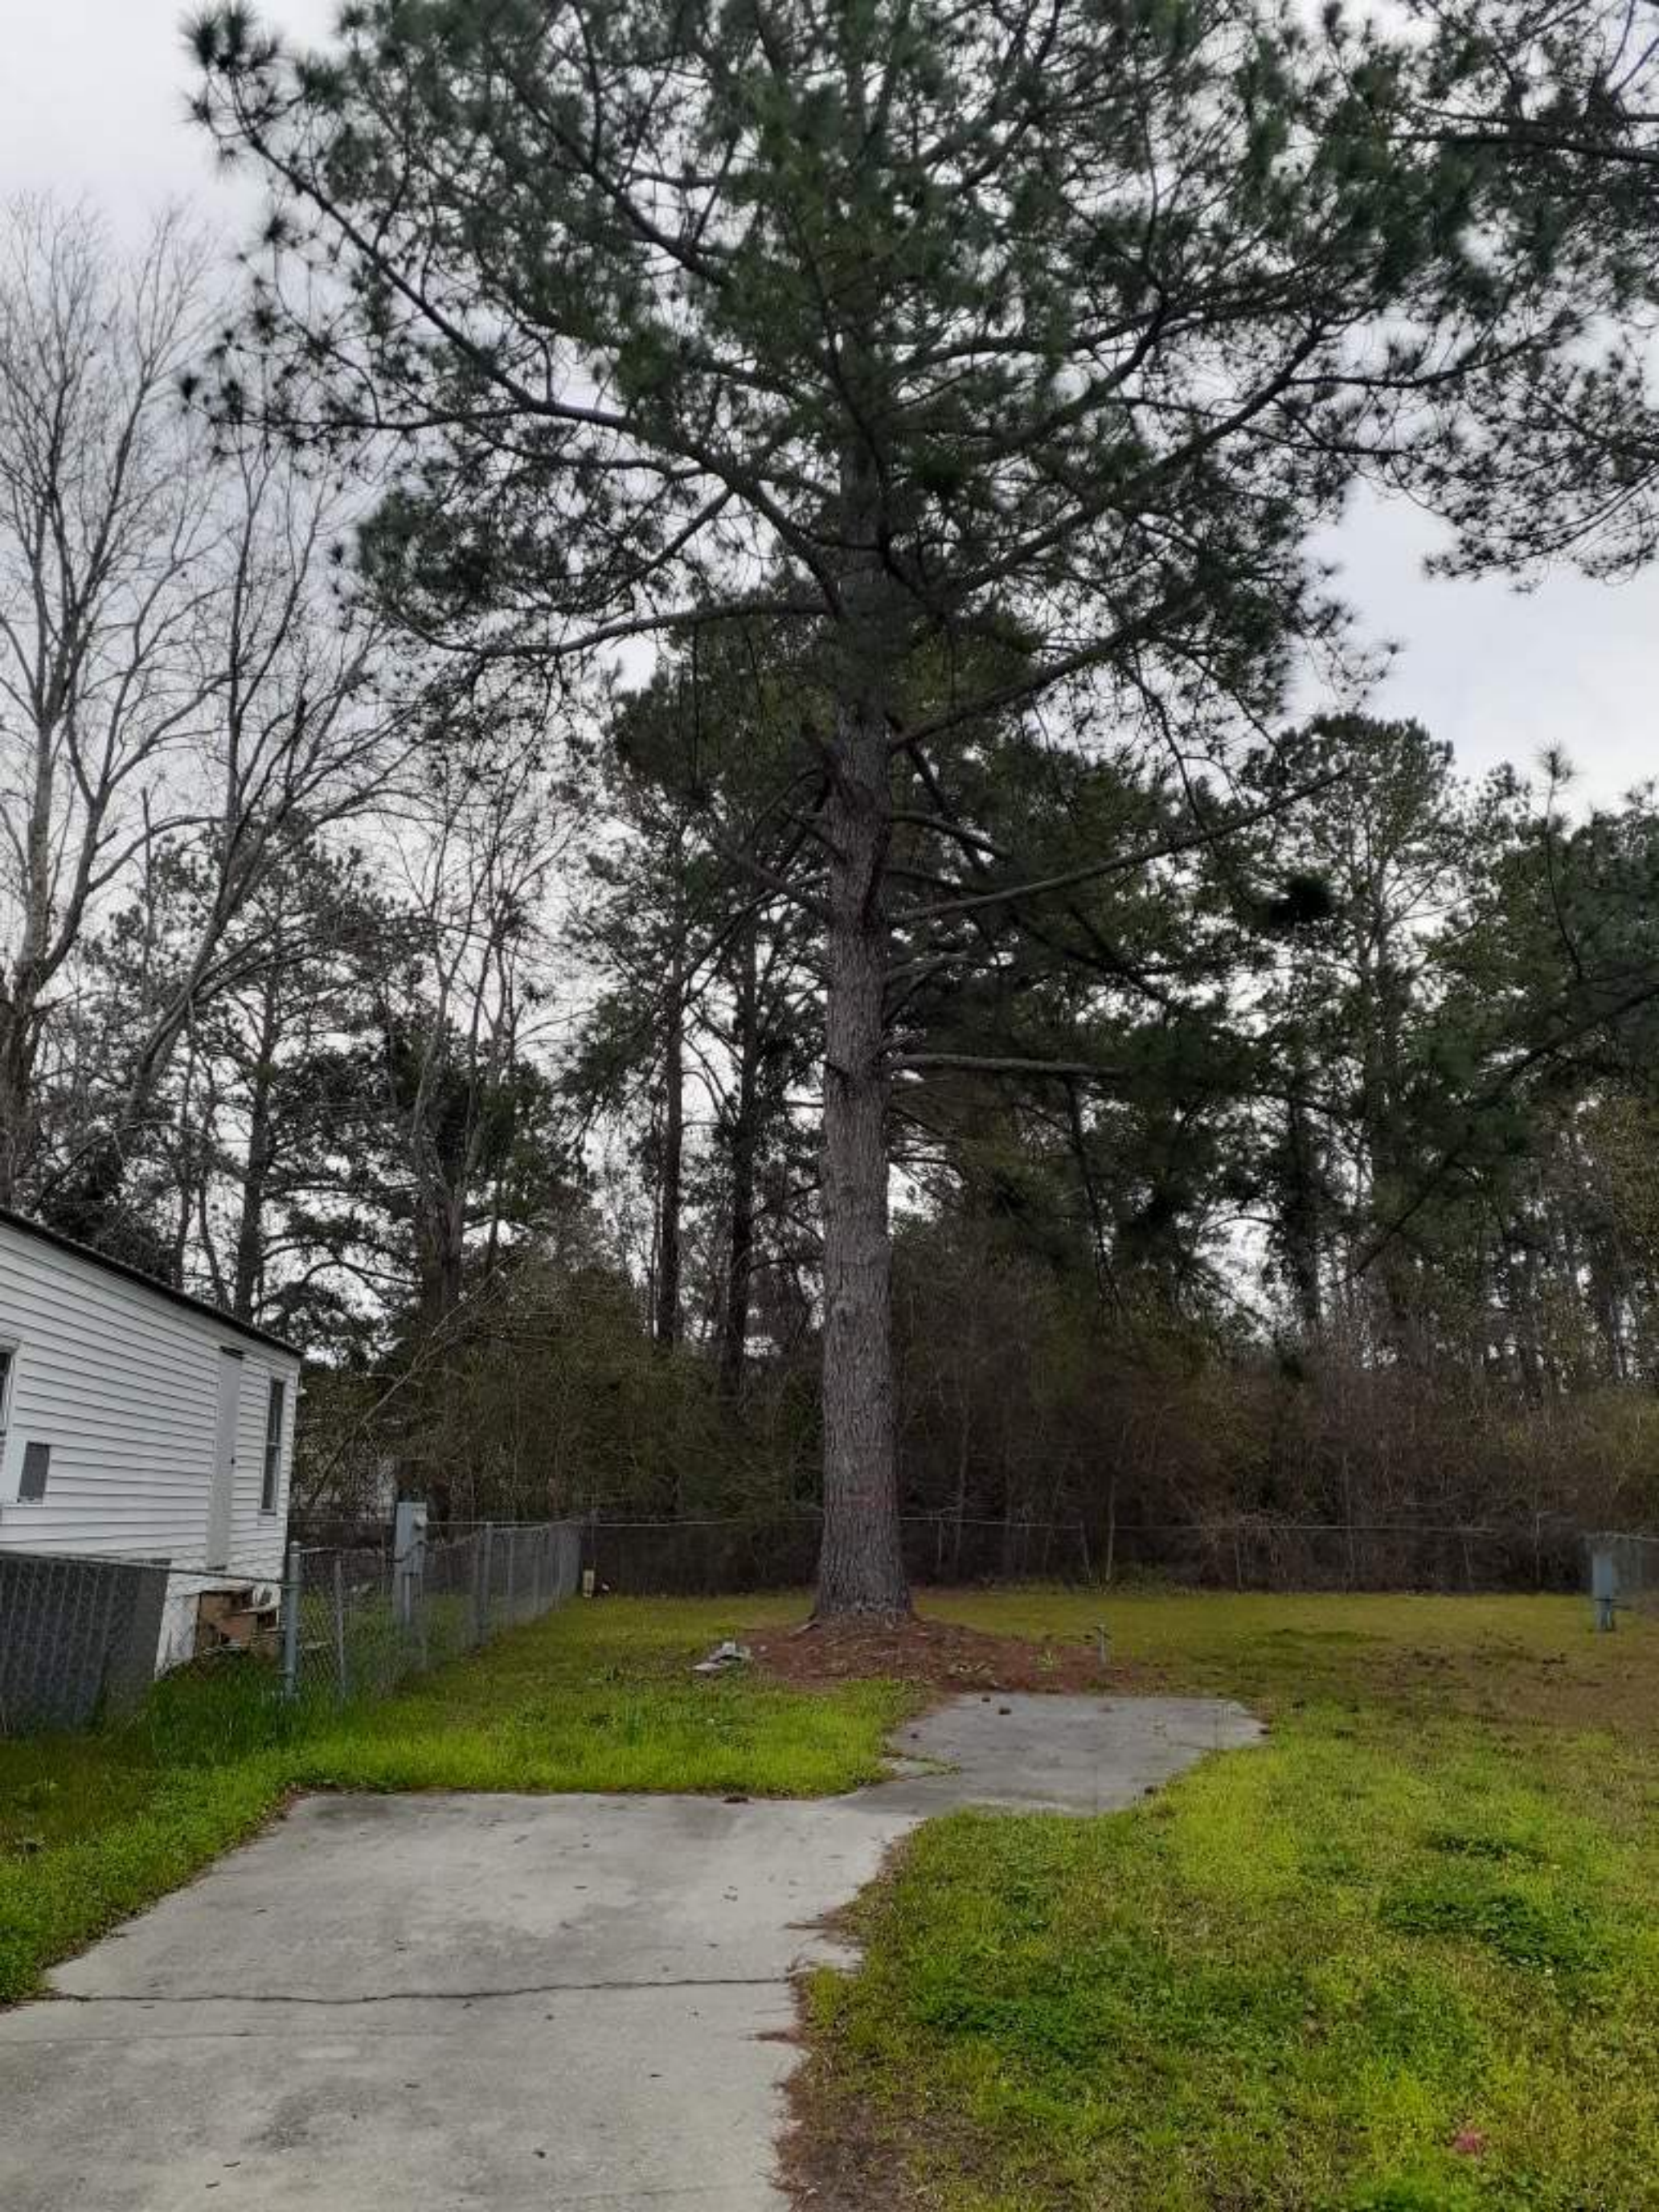
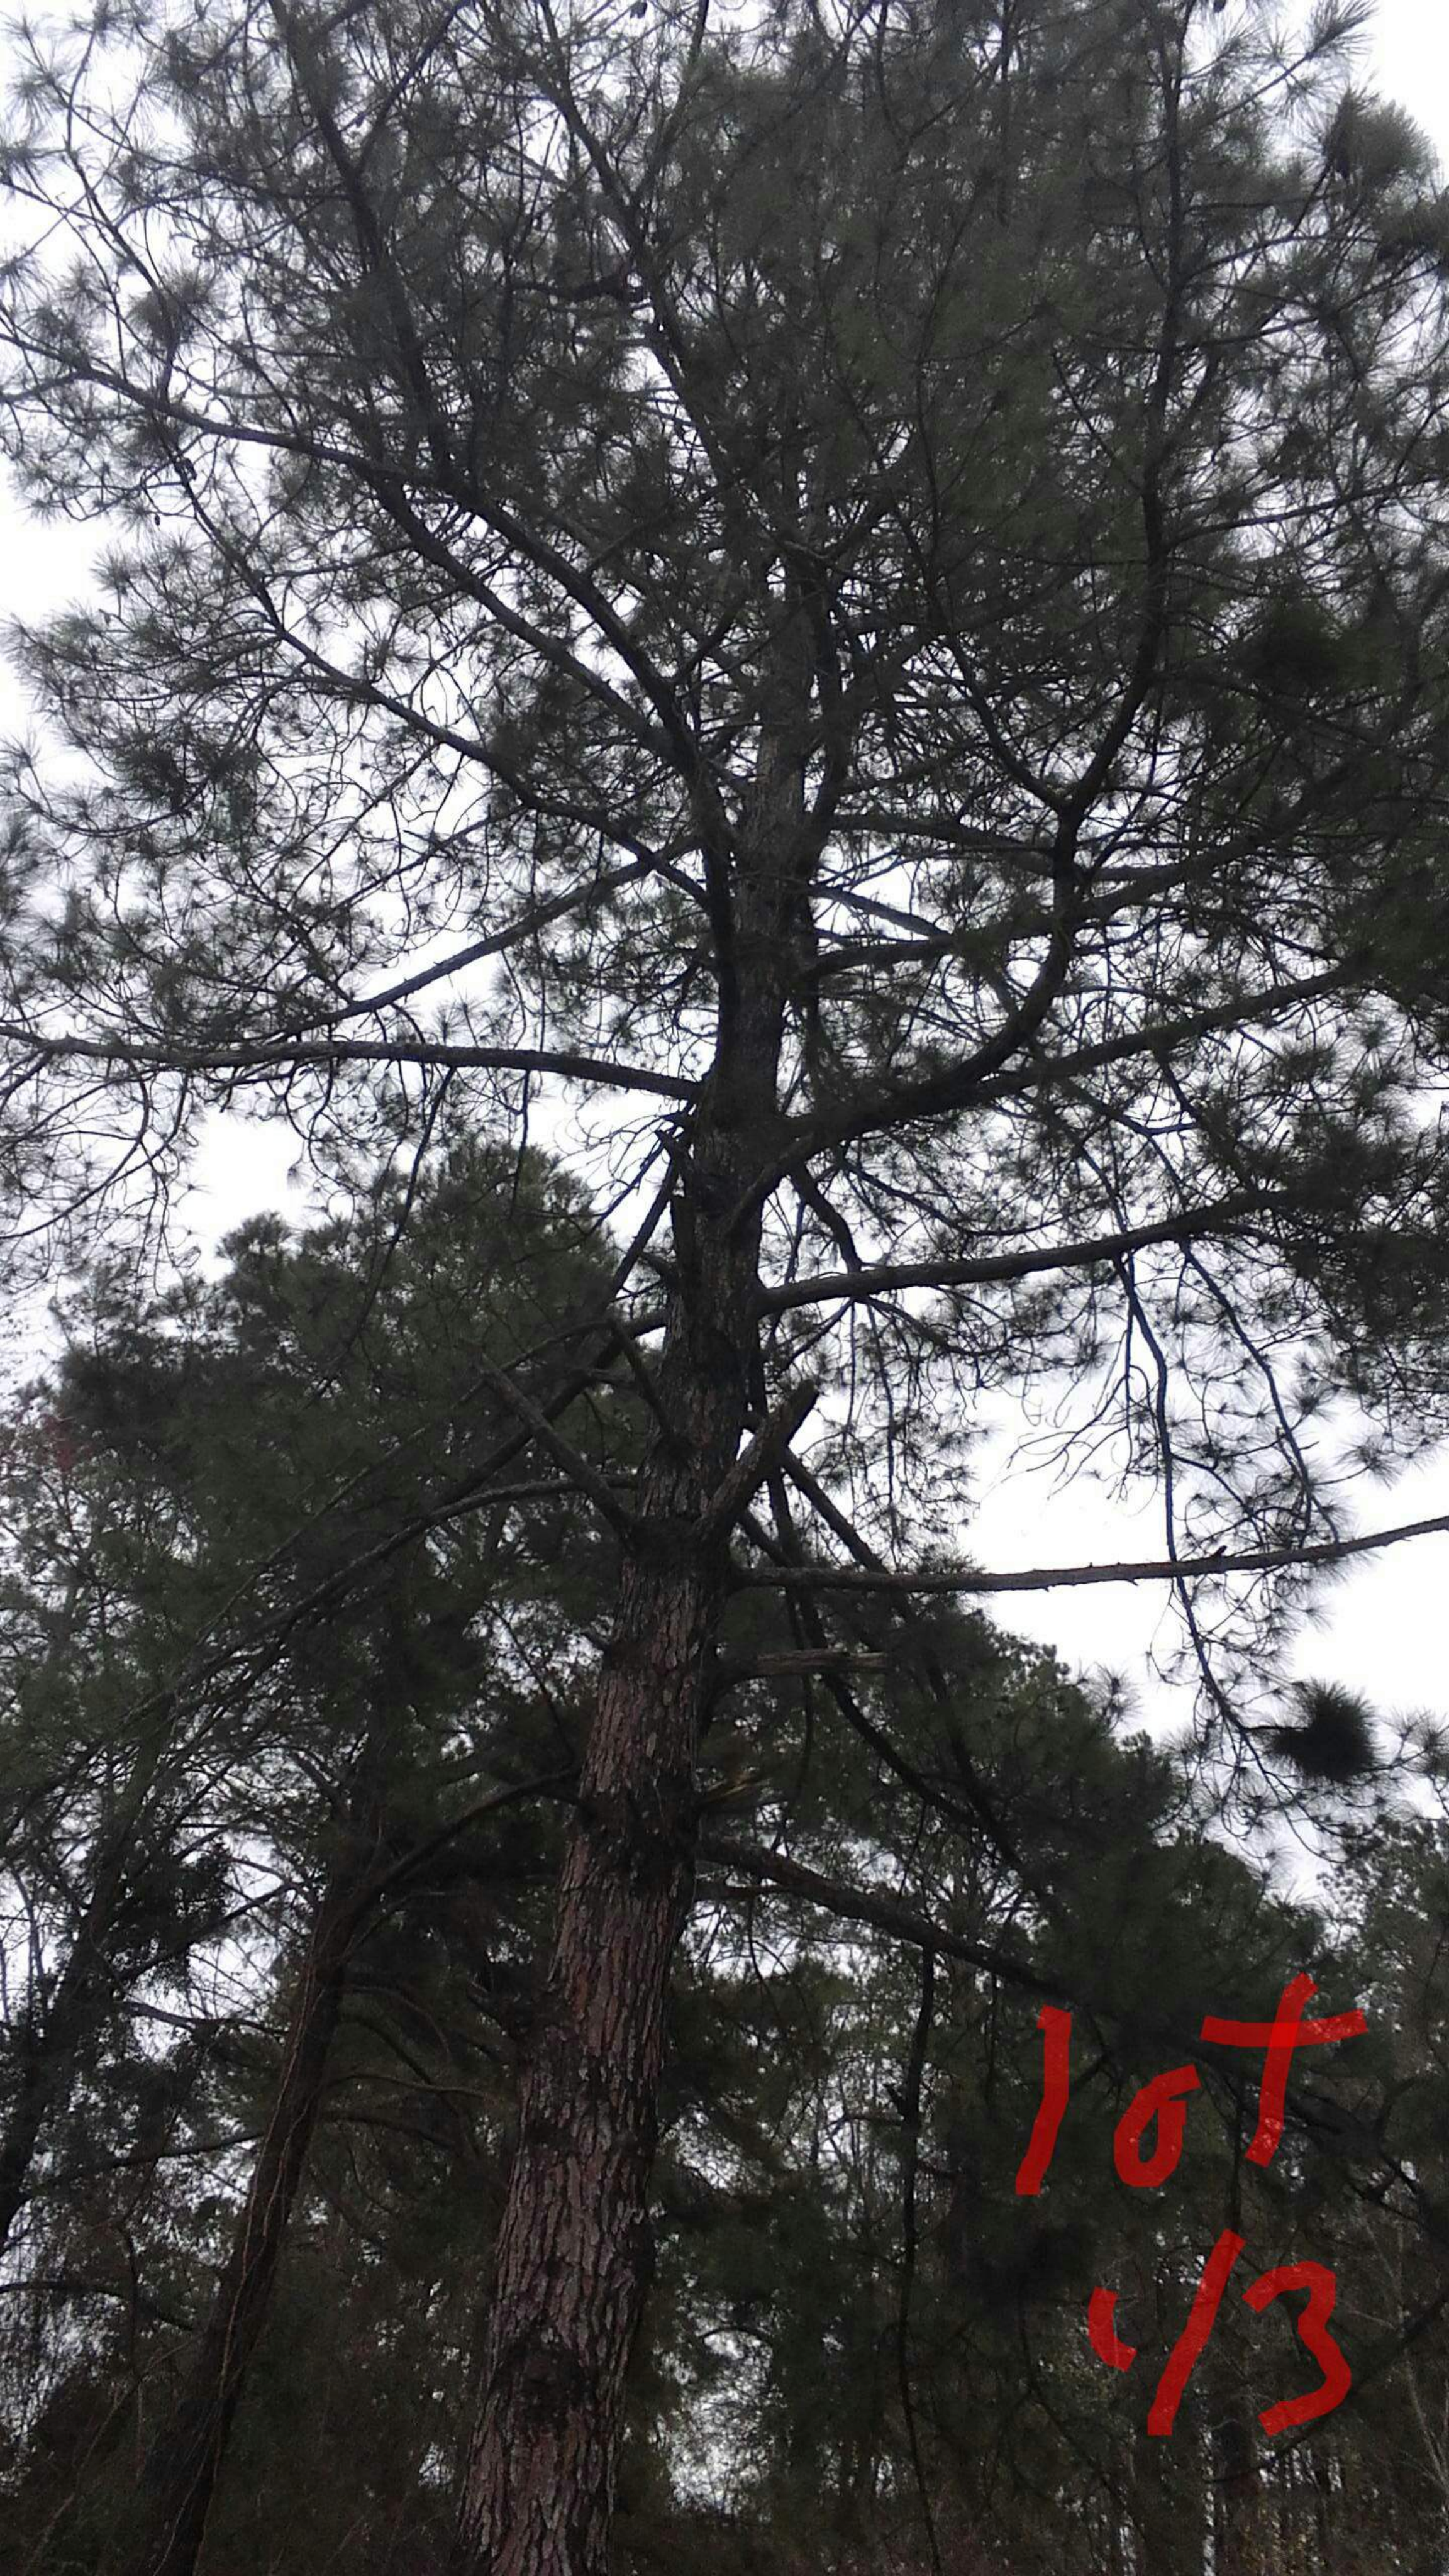
lot 43

Evaluation: Pine tree looks to be in good health.
